ARCHAEOLOGICAL EXCAVATION AT  
ASCOTT PARK,  
STADHAMPTON, OXFORDSHIRE

*AUGUST 2009*

# ARCHAEOLOGICAL EXCAVATION AT ASCOTT PARK, STADHAMPTON, OXFORDSHIRE AUGUST 2009

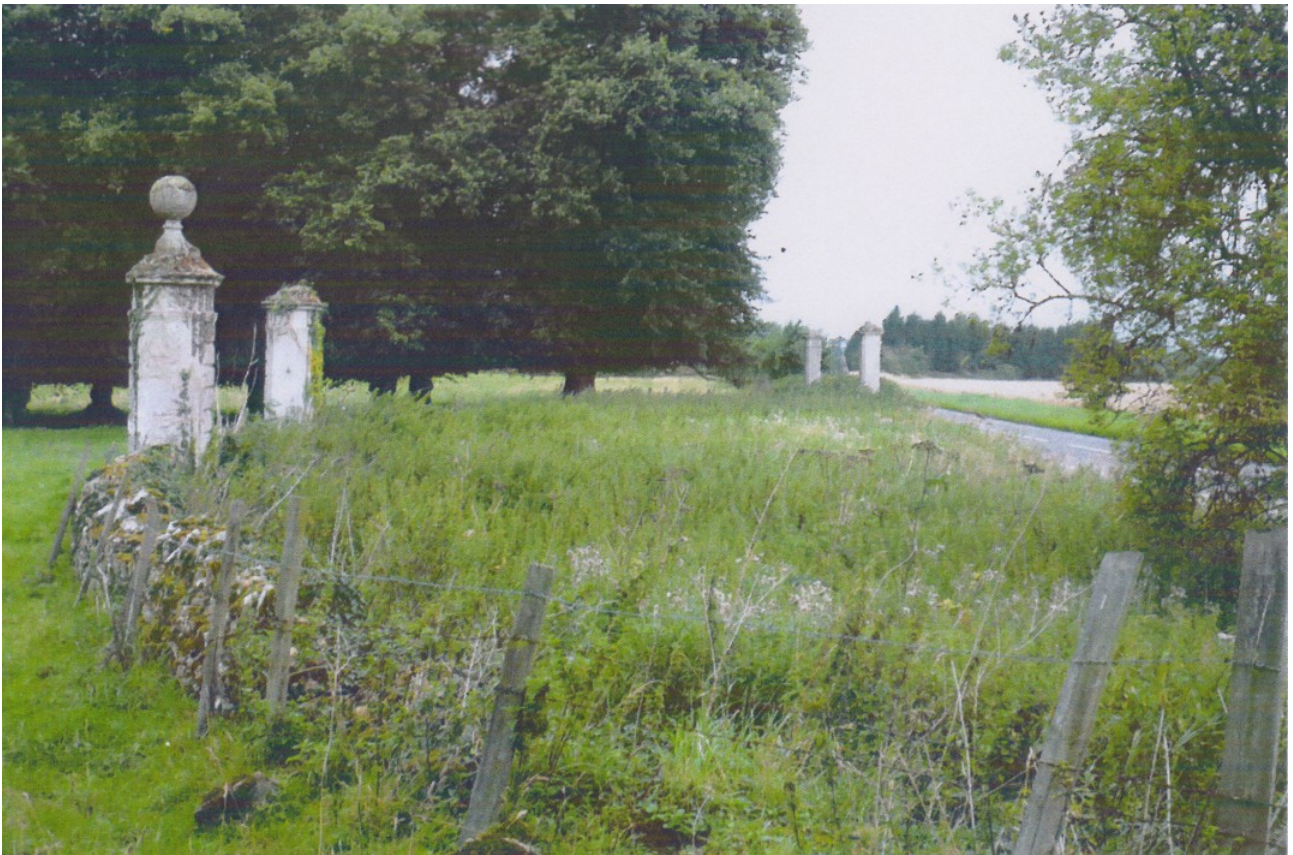
PLATE 1

- PL. 1 View looking west across semicircular entrance to Ascott Park.
- PL. 2 Trench 3, wall elevations and pillar foundation. Scale-rod 1-m long.
- PL. 3 Trench 7. Scale-rods in 0.5-m divisions mark the location of robber-trenches.
- PL. 4 Trench 5. Relationship between terrace retaining wall at right and existing boundary. Scale-rod 1-m long.
- PL. 5 Junction of terrace outer wall and present garden wall (Trench 6). Scale-rod 1-m long.
- PL. 6 Trench 6. Footings of terrace outer wall and possible step foundation Scale-rod 1-m long.
- PL. 7 Trench 7. Stone foundation of terrace outer wall with soil-filled border in foreground, Scale-rod 1-m long.
- PL. 8 Trench 9. Remains of steps.

To the visitor, passing Ascott Park along the B480 Stadhampton-Chalgrove road, the most obvious evidence of the former parkland setting are the remains of tree-lined avenues and the semicircular arrangement of stone gate-piers and masonry pillars that defines a sunken area adjacent to the southern kerbside (PL. 1). The intervening ground level appears to have been lowered by quarrying, presumably to excavate material for use in previous road building and repairs, but rises again once inside the park.

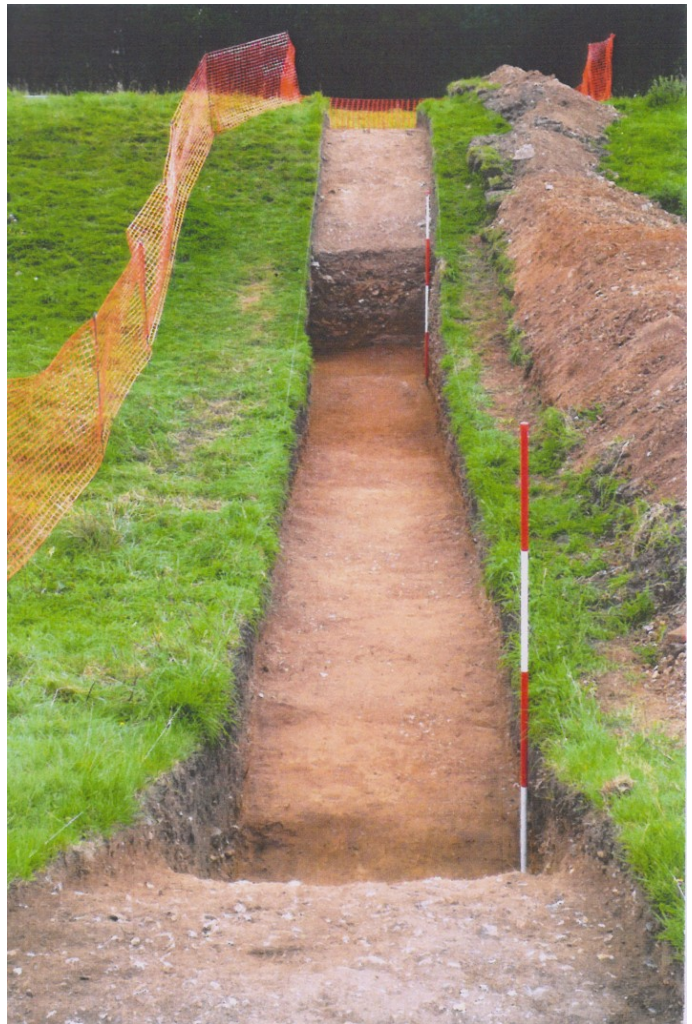
PLATE 3, right

covered by a thin layer of trampled soil, suggesting that it had not been exposed long enough for silt to accumulate or was possibly covered with a floor that was subsequently removed. There was evidence of a surrounding wall at each side (PL. 3). The base of a robber trench, 1.05 m wide and 140 mm deep, survived beneath the slope along the northern edge, which at this point had been formed by dragging the natural soil from behind into the hollow (ibid, foreground). A line of stonework visible in the surface nearby could represent the more complete survival of the wall that was otherwise taken away; it would repay future investigation.

A steep cut 1.35 m deep indicated where a corresponding wall had been removed from the south side of the hollow (ibid, distant scale-rod). Its edge fell sheer to the base of the original excavation and the way in which it ran out into the floor of the hollow suggests that the wall had formed one side of a sunken room in addition to supporting the terrace-bank. It was covered with material that had spilled over when the bank was no longer retained above. As well as exposing the natural soil profile, its face showed that it - or rather, the construction of the robbed-out wall also truncated an earlier feature, possibly a ditch of roughly V-shaped form but in the absence of finds of uncertain date. Pottery, bottle glass and other finds from the bank above suggest an eighteenth-century *terminus ante quern*, however. They include a base fragment of an imported Westerwald stoneware drinking vessel of the later seventeenth century (Gaimster 1997) in addition to a small number of body sherds of English domestic pottery, comprising Midland Black Ware (Barker 1986), delftware and pancheon-type coarse wares (ASP/09/07/01-03). Pieces of green glass wine bottles dated c. 1680-1730 and bowl fragments of clay tobacco pipes from the same period are also present (G. Egan, pers. comm.).

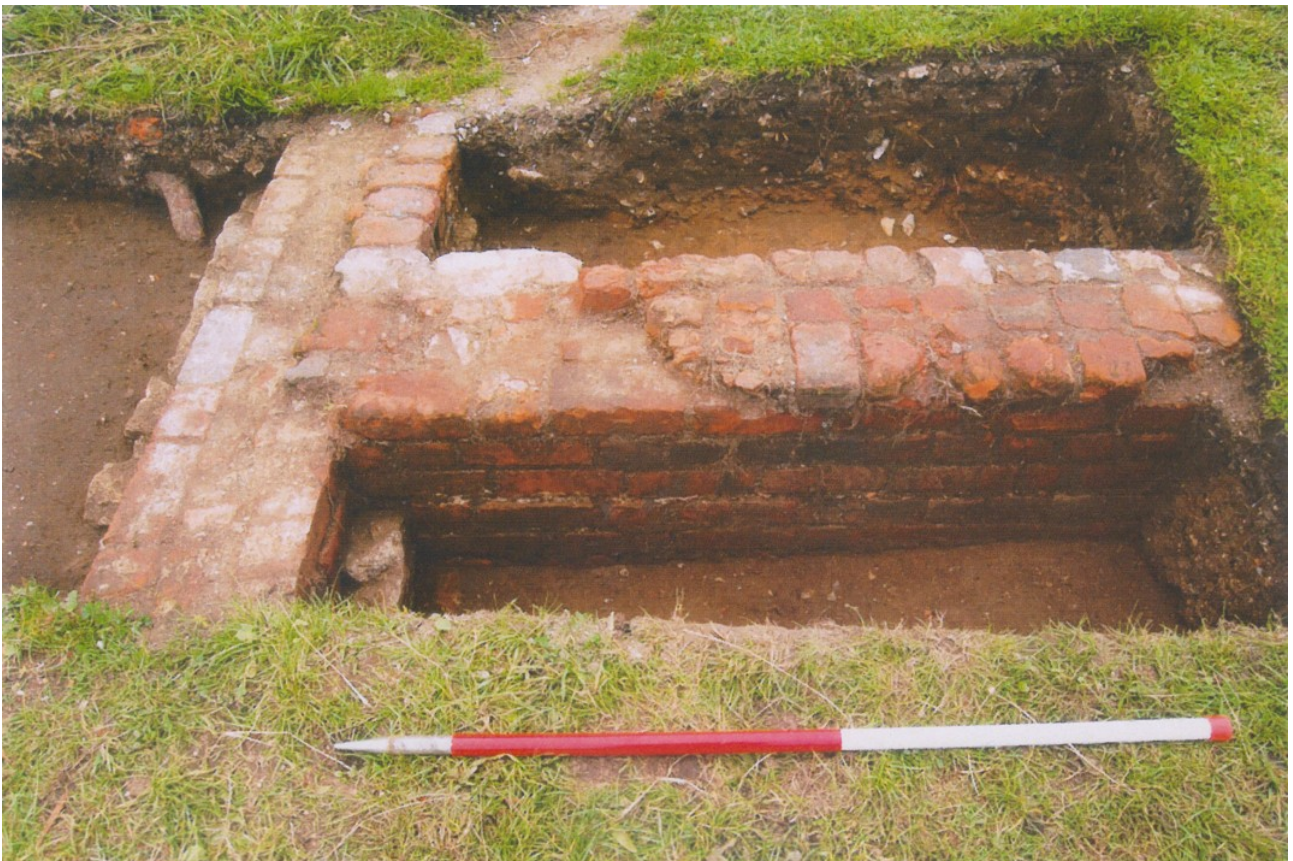
PLATE 4, below

The brick wall made a straight joint with another that was perpendicular to it but did not abut against it at an exact right angle (PL. 4). The stratigraphic relationship between the two suggests that the north-south wall already existed when the terrace was added. It was of a similar size and construction but not as deeply founded, so that the new wall rested on part of its footings. Although on almost the same alignment as the eastern boundary of the garden, now shared with Ascott Park Cottage, it is nevertheless slightly out of line and investigation of an area beside the surviving property wall suggests that the continuation southwards is a later extension (Trench 6. See further below).

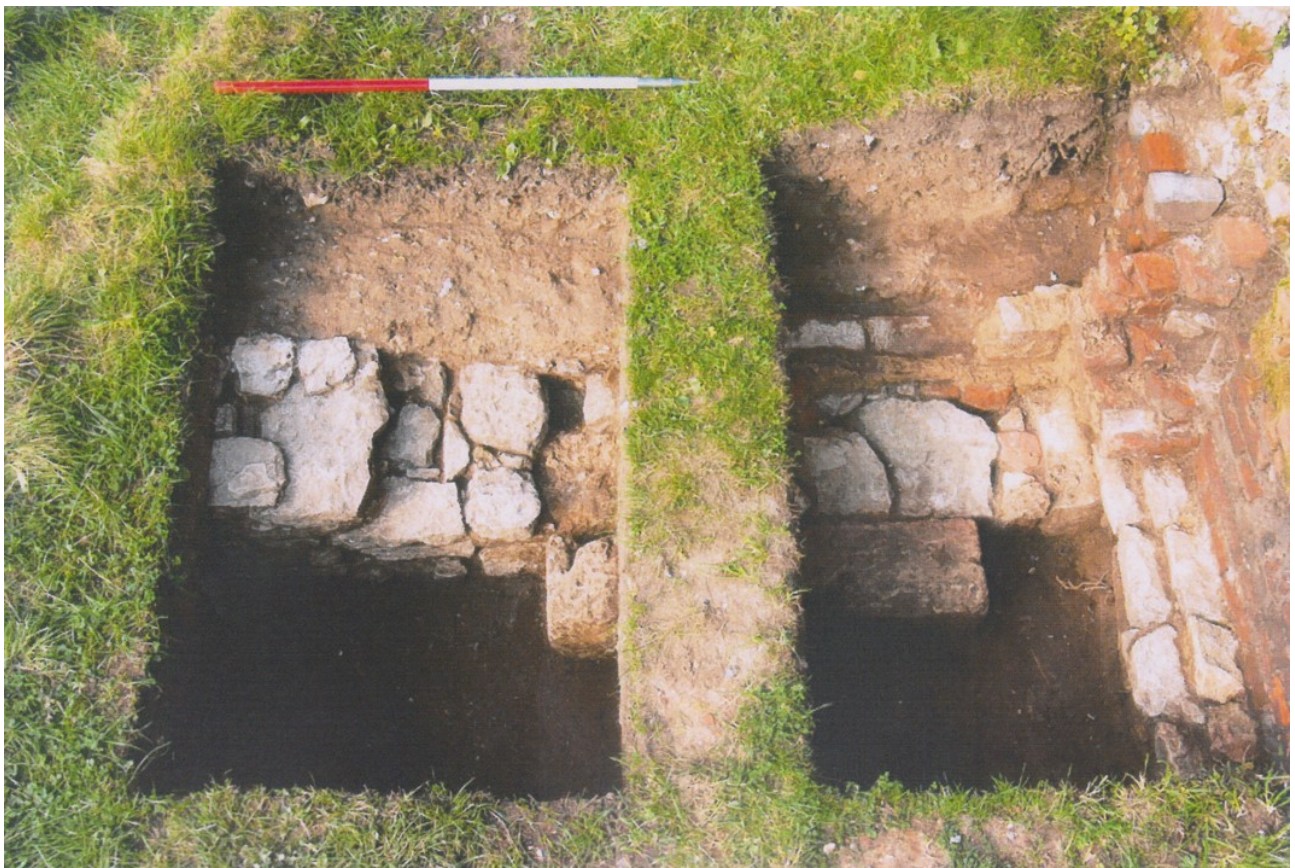
PLATE 6, below

Although the brick superstructure of the terrace wall had been dismantled and part of the adjacent bank was damaged, a partially mortared limestone foundation 0.44 m or 18 inches wide remained (Trench 6). A large rectangular block of ashlar, reddened by burning along one edge and clearly re-used, had been placed along the outer edge of the wall, possibly to form the base of a step (PL. 6).

The arrangement of steps at the opposite or top end of the garden also appears to have differed from the ideal represented in the historical plan. Although robbing had damaged the top of the foundation of the brick wall in front of the terrace and part of the adjacent bank, a re-used large ashlar block next to the corner could have served as a sill at the base of a narrow flight of steps. The survey, however, shows only central steps that are so far unproven.

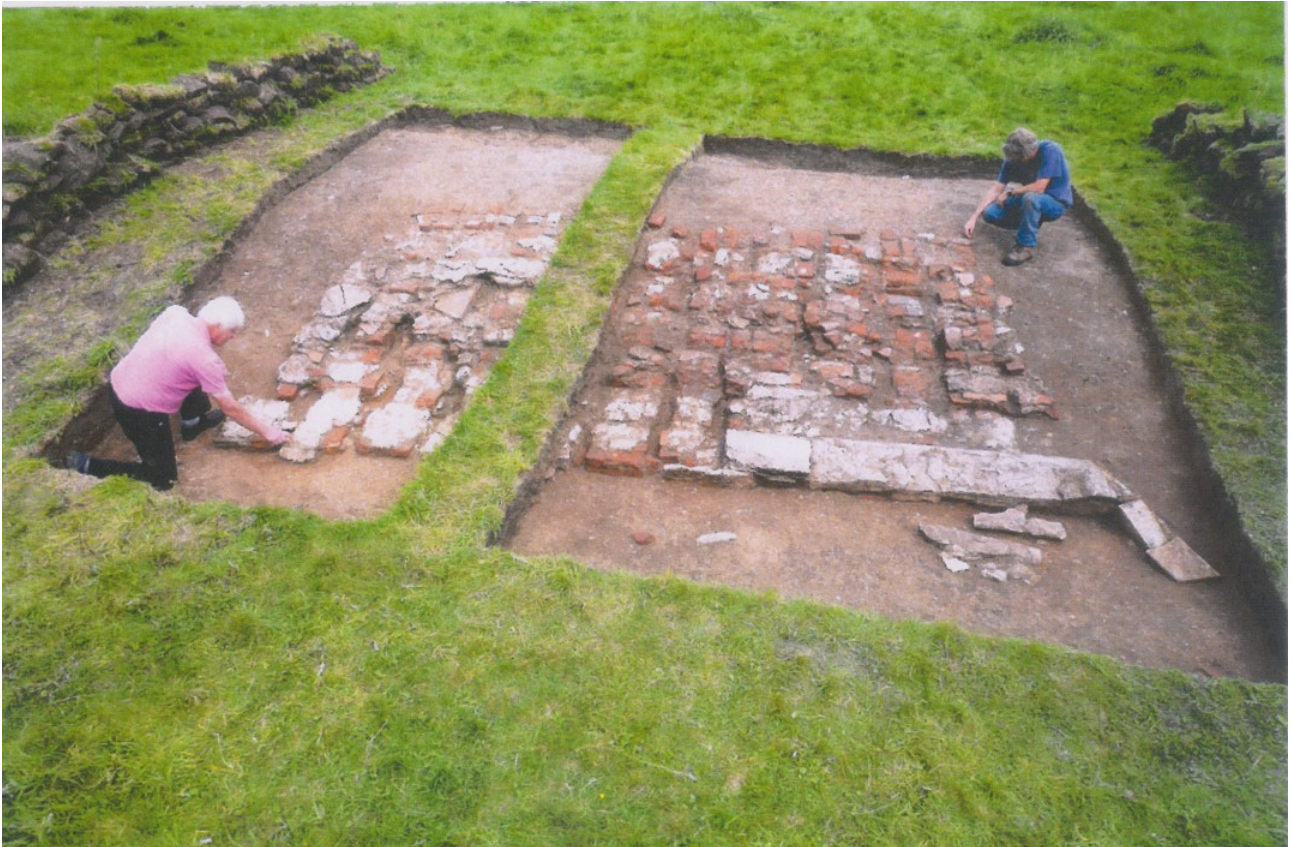
PLATE 8

The steps were offset from the line of the central north-south path but it remains uncertain whether this was intentional or a mistake of laying out, or if they formed part of a pair at either side of the main path. The surviving structure formed an approximate rectangle 5.20 m long and 2.60 m wide (c. 17 feet by 8 feet 6 inches) and had been built into the slope with slightly concave sides and splayed lower corners, which may have been intended to support the stop-ends of a parapet (PL. 8).

The foundation was made up of eleven strips of brickwork slanting longitudinally down the slope, with the spaces between them presumably for drainage. Within each line a few courses of un-mortared brick had been stepped into the ground and spot-bedded onto a layer of sand - structurally strong enough, but with no evidence of a deeper foundation. The individual stone treads had been bonded onto this arrangement and enough survived to indicate that the flight originally contained seven steps made out of the local Portland Stone from the area of the Miltons and Haseleys. Some of the stones appear to have been robbed for re-use but others were left behind where they had broken or shattered, including a large bottom slab 1.70 m by 0.35 m (c. 6 feet 6 inches by 14 inches).
